**Subject:** Enhanced Evaporation Update

Per your request, here's a quick update on the Enhanced Evaporation Pilot Test.

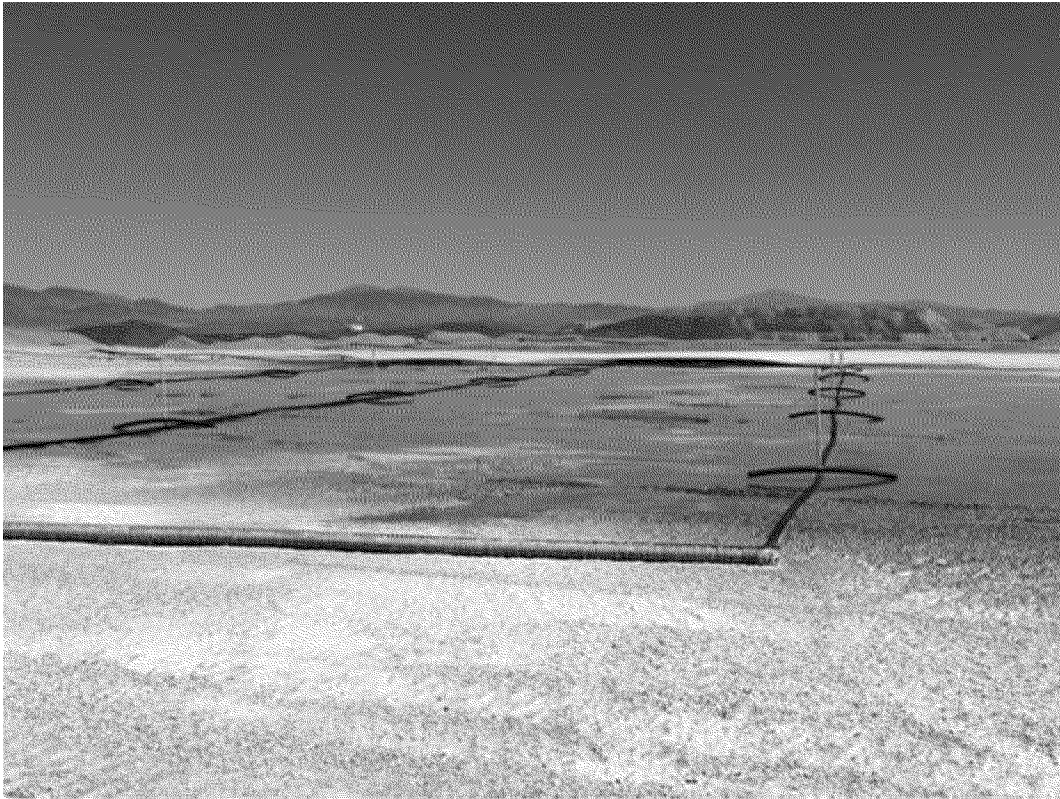
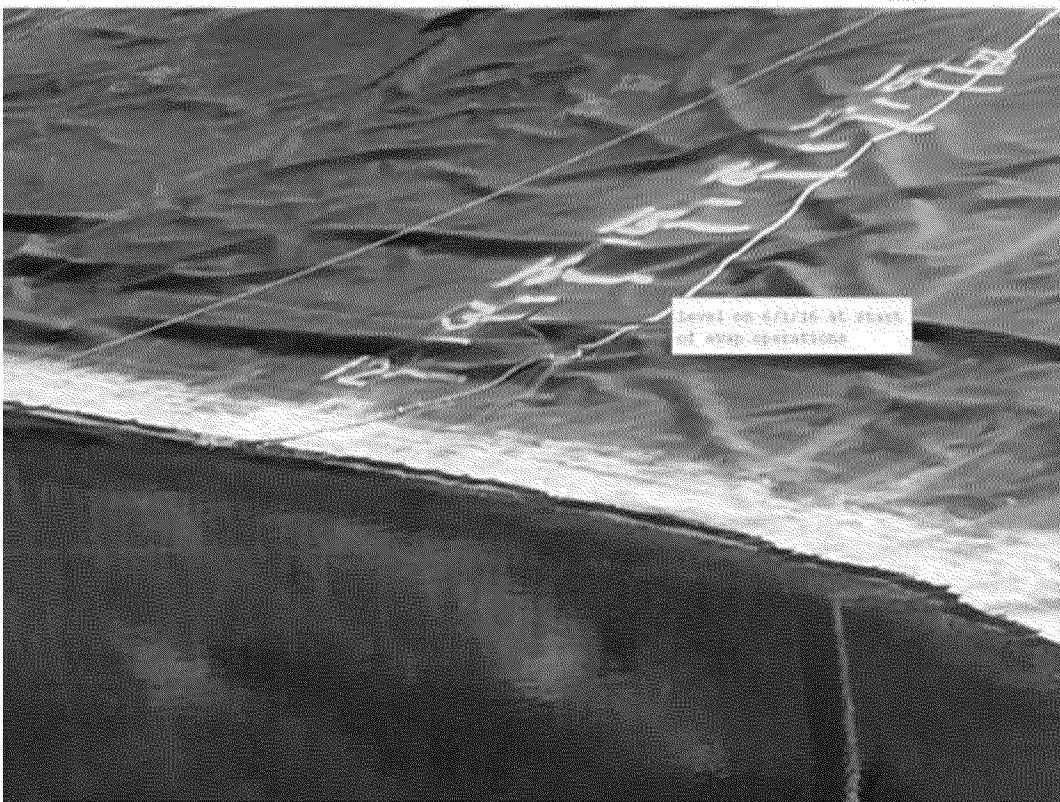
Evap Panel Surface - Precipitate crust continues to form (before & after pumping photos attached). Fluid appears to sit on top of this crust during pumping operations. We are monitoring VLT drain-down rates to evaluate potential recirculation.
